# DIAGTECH®

## TECHNICAL DIAGNOSTIC INFRARED THERMOGRAPHY ULTRASOUND

### PREVENTIVE MAINTENANCE INSPECTION : PERTINENT EXAMPLES OF PROBLEMS THAT CAN BE DETECTED WITH INFRARED THERMOGRAPHY

Thermographic inspection of some equipments

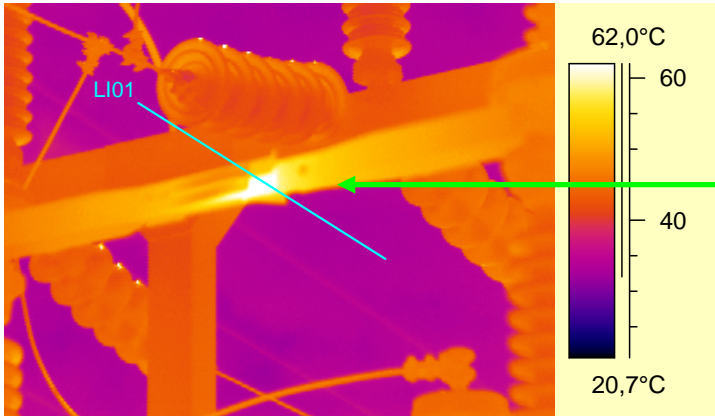
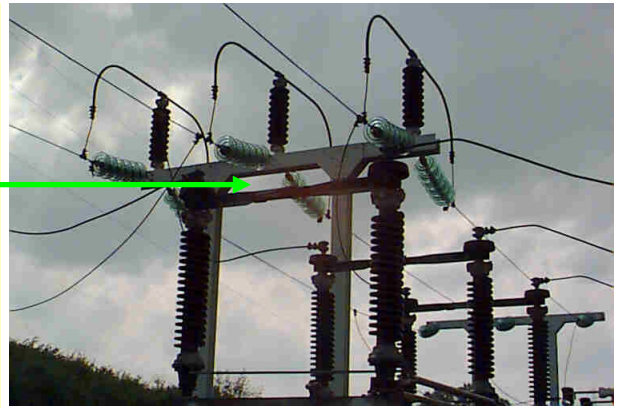
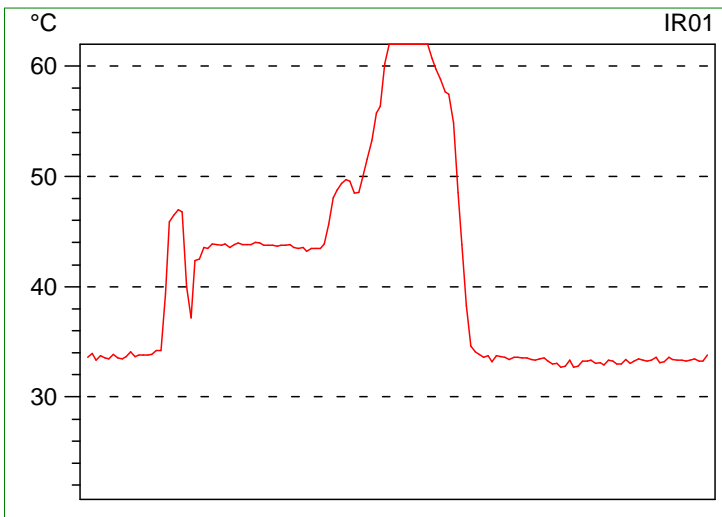
BUILDING / PREMISES	EQUIPMENT	COMPONENT
DELIVERY STATION	DISCONNECTING SWITCH TRANSFORMER 3	BAR 3021

IR information	Value
Date of creation	27/08/1997
Time of creation	14:48:06
File name	H0827-31.img
Camera type	THV 550
Camera serial number	656089
Camera lens	10
Object parameter	Value
Emissivity	0,60
Label	Value
LI01 : max	63,6°C
LI01 : min	32,7°C

HEATING OF THE CONNECTION BETWEEN THE FIXED PART AND THE MOBILE PART OF THIS HIGH TENSION DISCONNECTING SWITCH. THE HOTTEST POINT IS ON LI01.

JUST MAKE A MAINTENANCE WORK ON THE CONNECTION OF THIS POLE. CONTROL THE ELIMINATION OF THE DEFECT WITH THE HELP OF AN INFRARED THERMOMETER WITH LASER AIMING. ACT ACCORDING TO THE RESULTS. INTERVENE WITHIN TWO OR FOUR WEEKS.

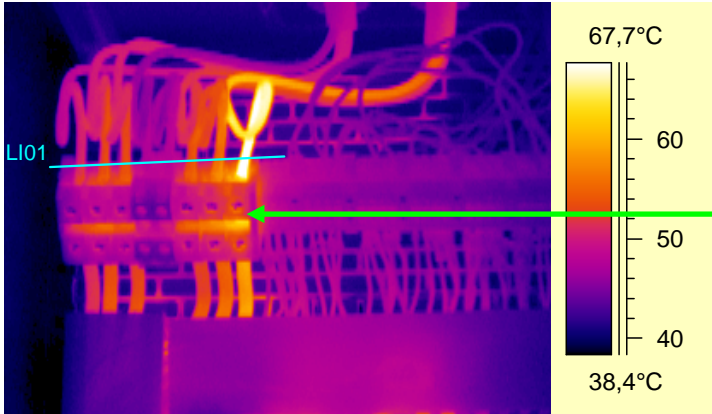
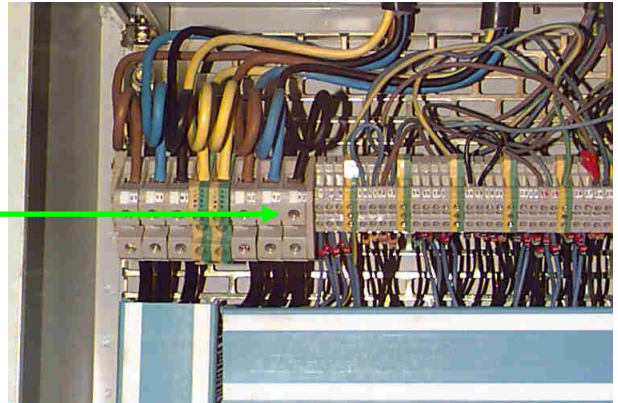
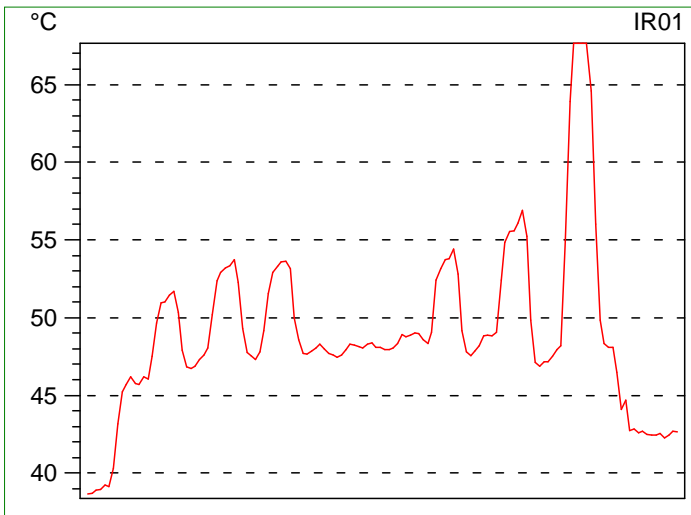
BUILDING / PREMISES	EQUIPMENT	COMPONENT
SUBSTATION PUMPING	CUPBOARD PUMPS	TERMINAL HOLDER D2

IR information	Value
Date of creation	18/07/1996
Time of creation	08:47:25
File name	G0718-01.img
Camera type	THV 550
Camera serial number	656089
Camera lens	20
Object parameter	Value
Emissivity	0,98
Label	Value
LI01 : max	69,0°C
LI01 : min	38,7°C

SIGNIFICANT HEATING OF THE BLACK CONDUCTOR ON THE UPPER SIDE OF TERMINAL HOLDER D2.  
TIGHTENING PROBLEM.

CONTROL THE STATE OF THE TERMINAL AND THE CONDUCTORS, REPLACE AND / OR SHORTEN IF NECESSARY.  
INTERVENE WITHIN TWO OR FOUR WEEKS.

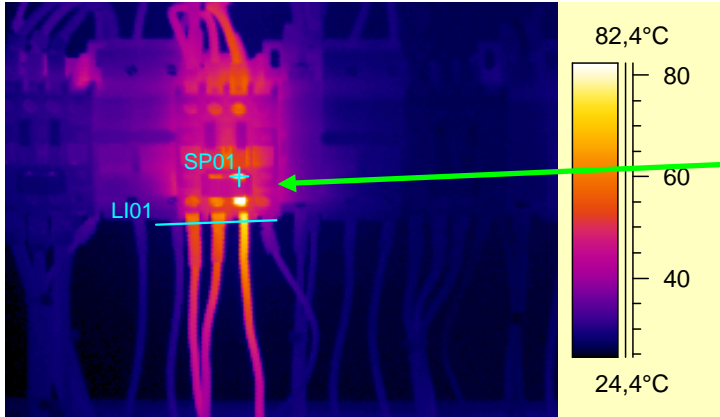
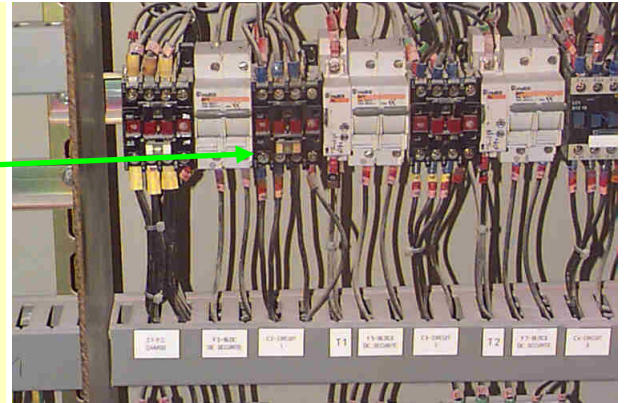
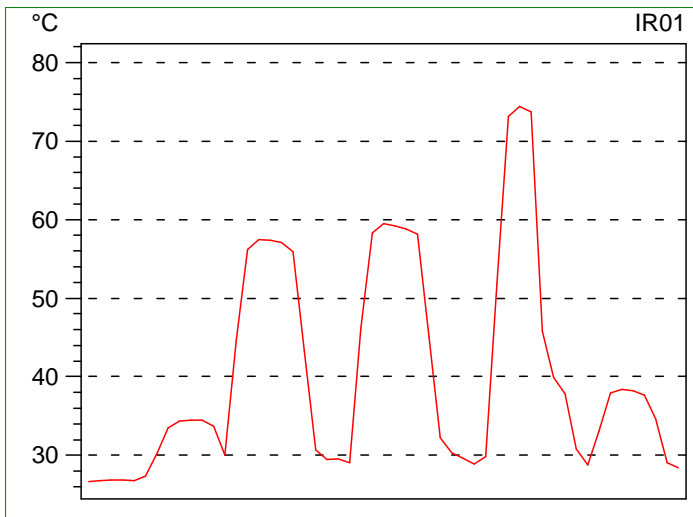
BUILDING / PREMISES	EQUIPMENT	COMPONENT
PACKAGING	CUPBOARD CONVEYOR	CONTACTOR 7Q1

IR information	Value
Date of creation	10/09/1996
Time of creation	12:58:53
File name	G0910-31.img
Camera type	THV 550
Camera serial number	656089
Camera lens	20
Object parameter	Value
Emissivity	0,98
Label	Value
SP01	92,0°C
LI01 : max	74,4°C
LI01 : min	26,7°C

SIGNIFICANT HEATING OF THE CONDUCTOR, BELOW ON THE RIGHT SIDE OF THE SWITCH. NEVERTHELESS THE FIRST CAUSE IS INSIDE OF THE CONTACTOR (SP01 AT +92°C). THE HEATING HAPPENS BETWEEN THE FIXED CONTACT AND THE MOBILE CONTACT OF THIS PHASE ON THE LOWER PART OF THIS EQUIPMENT.

REPLACE THE CONTACTOR.  
INTERVENE WITHIN TWO DAYS.

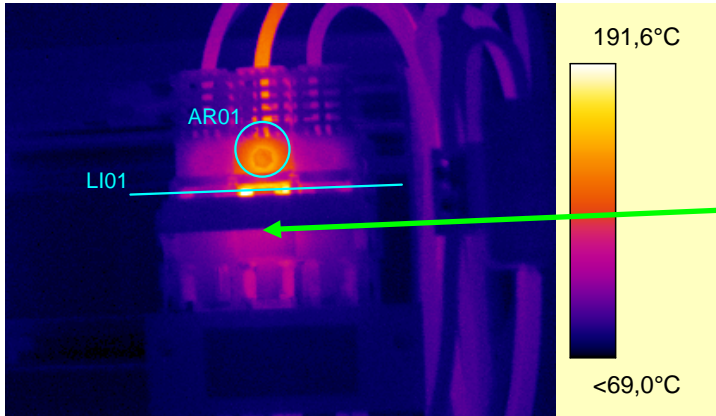
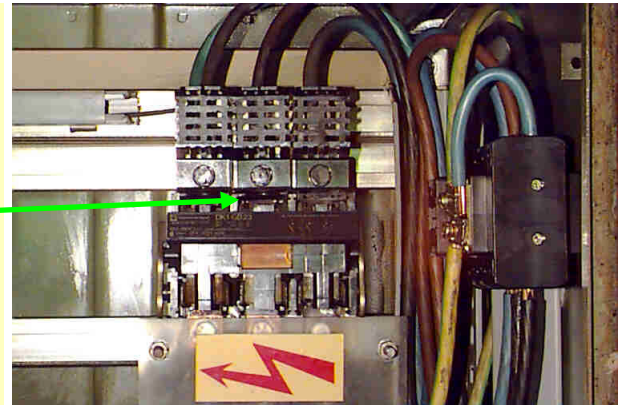
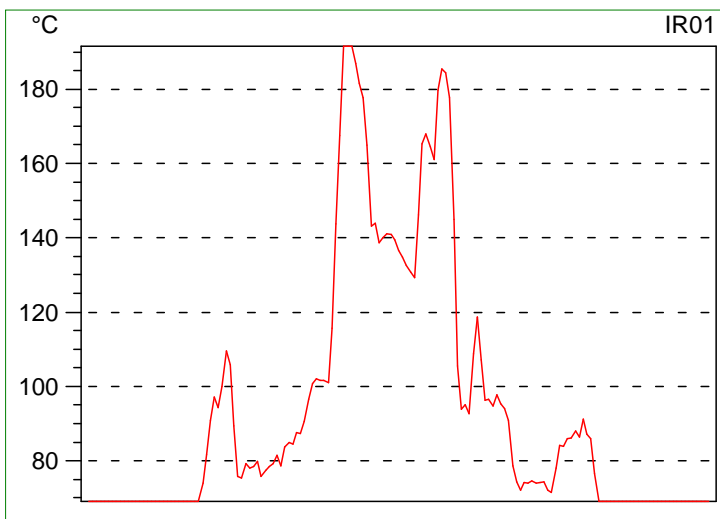
BUILDING / PREMISES	EQUIPMENT	COMPONENT
BOILER ROOM	CUPBOARD PUMPS	FUSES SWITCH Q1

IR information	Value
Date of creation	03/12/1996
Time of creation	10:06:11
File name	G1203-13.img
Camera type	THV 550
Camera serial number	656089
Camera lens	20
Object parameter	Value
Emissivity	0,98
Label	Value
LI01 : max	197,7°C
LI01 : min	<69,0°C
AR01 : max	152,1°C

VERY SIGNIFICANT HEATING OF THE CONNECTION BETWEEN THE FUSE AND ITS SUPPORT ON THE UPPER PART OF THE CENTRAL PHASE.  
BUCKLING OF THE PINCHING BLADES OF THE FUSE.

REPLACE THE SWITCH AND THE FUSES.  
INTERVENE AS QUICKLY AS POSSIBLE.

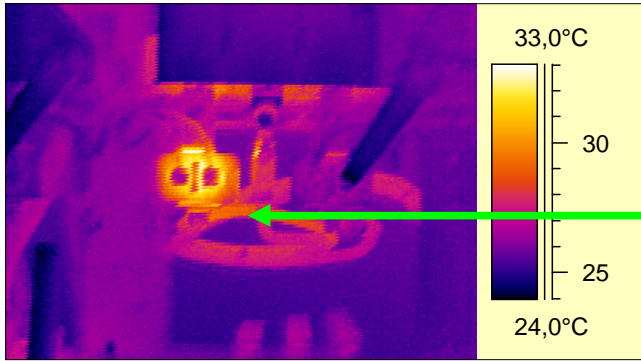
ON ONE OF THE LOOPS YOU CAN SEE THAT THE STRENGTH'S TRANSFORMER IS HEATING ABNORMALLY.

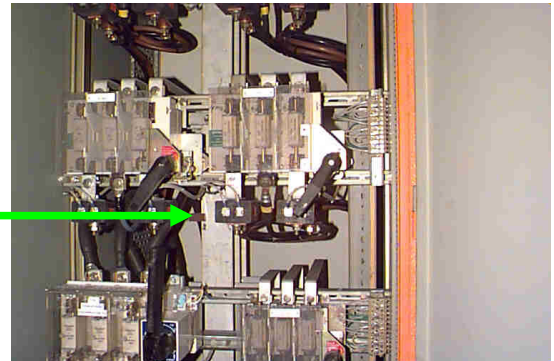
BADLY CARRIED OUT SETTING ON THE LEFT PHASE.

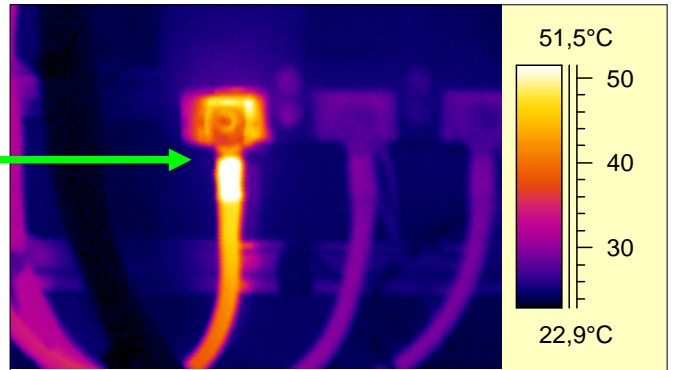
EXCESSIVE HEATING ON SOME POLES OF THIS CUTOUT.

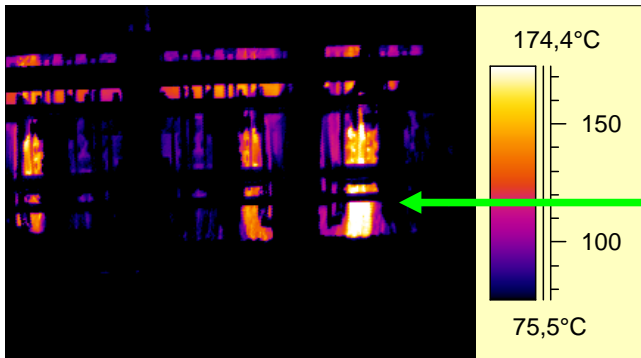
A CONDENSER OF THIS BATTERY SHOWS AN ABNORMAL TEMPERATURE INCREASING.

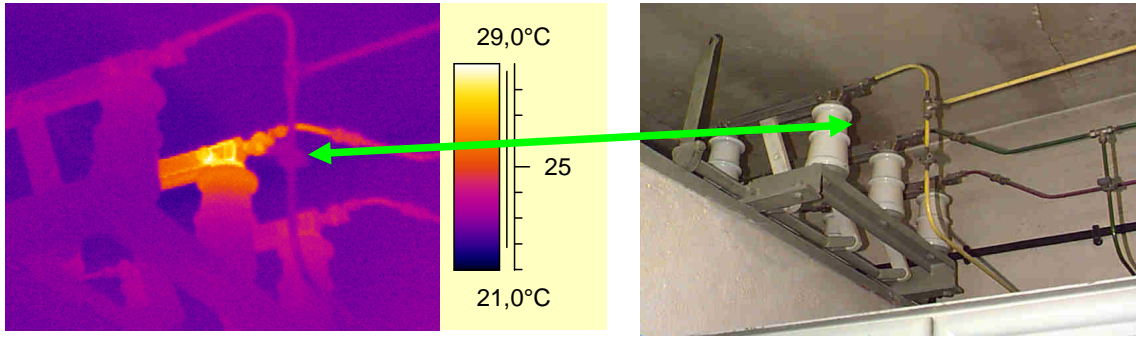
CONNECTION PROBLEMS ON THE MIDDLE PHASE.

SIGNIFICANT TEMPERATURE INCREASING ON THE RIGHT AND LEFT PHASES, OF THE LOWER PART OF THIS SWITCH.

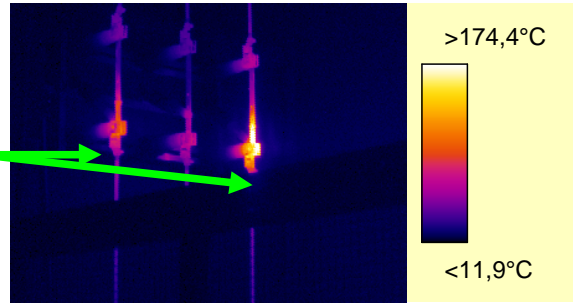
CONNECTION PROBLEM AT THE CABLE HEAD ON THE RIGHT PHASE OF THIS TRANSFORMER

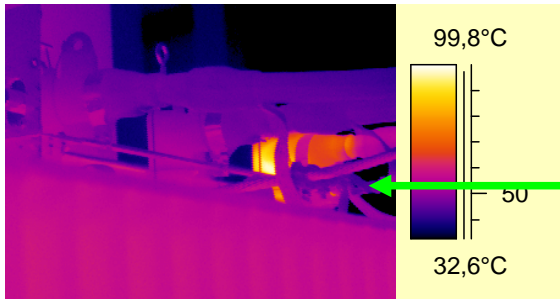
INTERNAL HEATING OF THIS STRENGTH'S TRANSFORMER EVEN THOUGH THE LOAD IS BALANCED ON THE THREE PHASES.

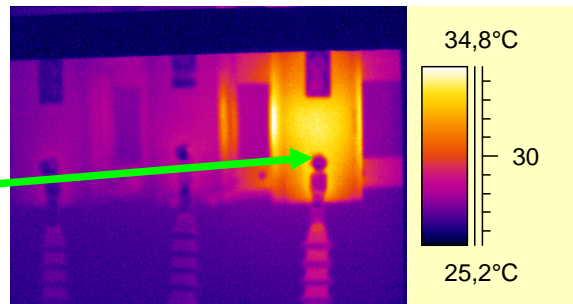
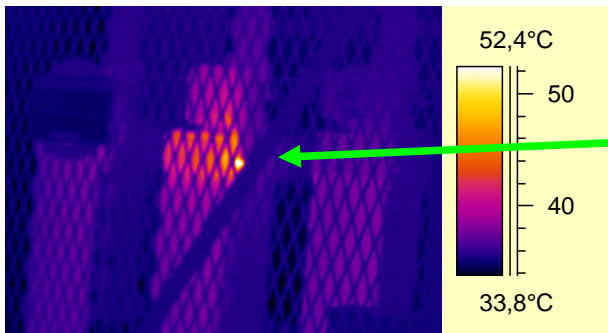
HEATING OF THE UPPER CONNECTION OF THE CENTRAL FUSE.

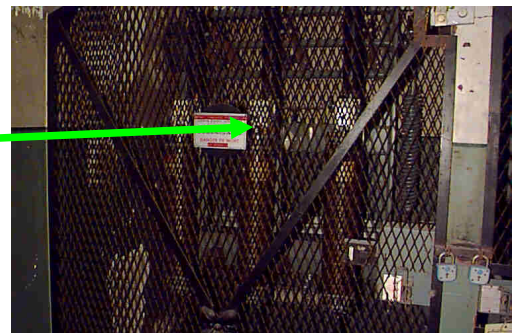
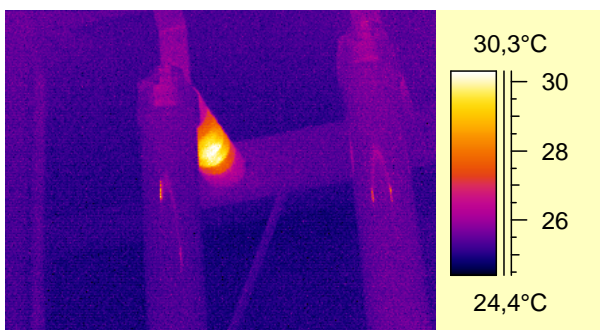
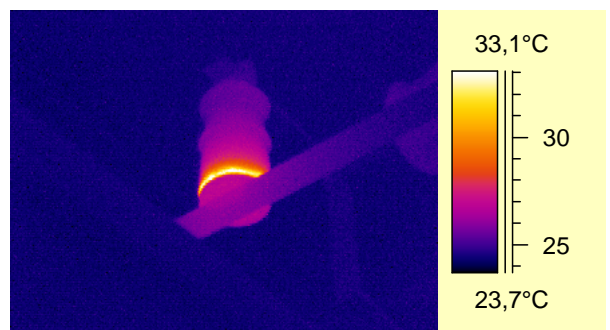
ABNORMAL HEATING OF BOTH INSULATORS !
