<b>BUILDING / PREMISES</b>	ROOF
<b>EQUIPEMENT</b>	2nd RAW FROM THE LEFT / LOWER LINE
<b>COMPONENT</b>	PANEL

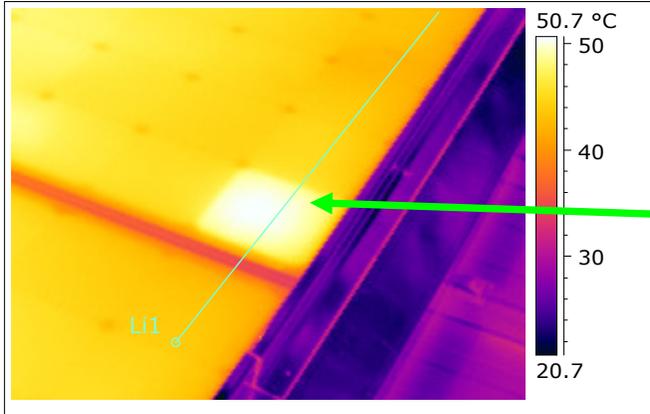
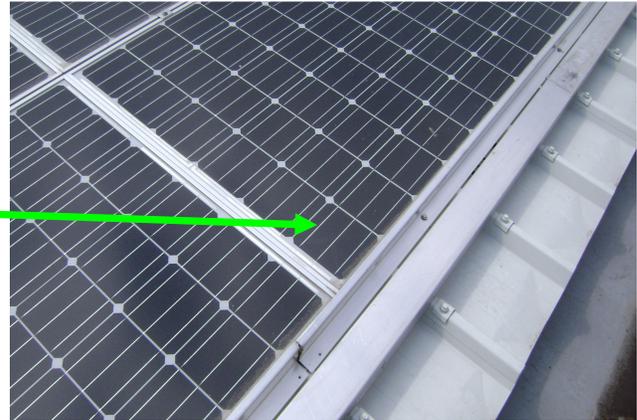
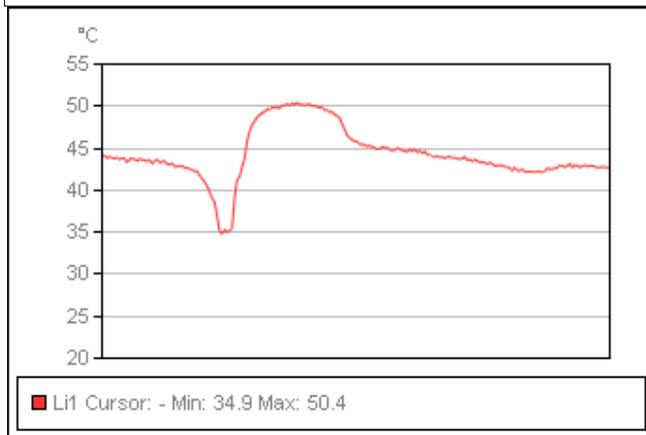
**RISK** 3

Cloudy skies, panels are at 50% capacity.  
Defective Wafer en Ar1.

Replace this panel.  
INTERVENE WITHIN TWO TO FOUR WEEKS.

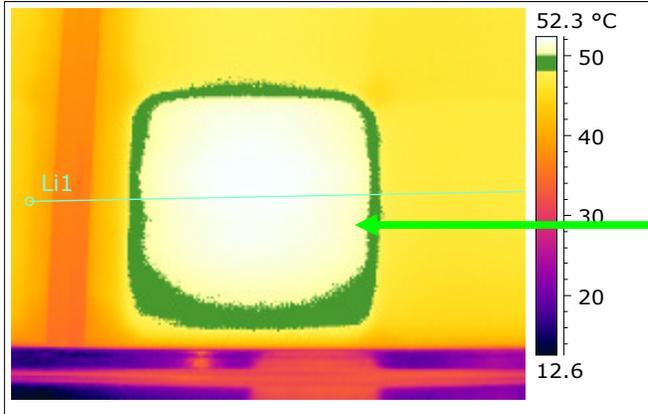
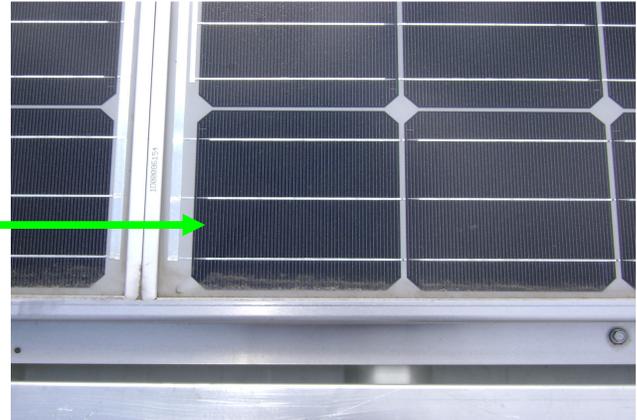
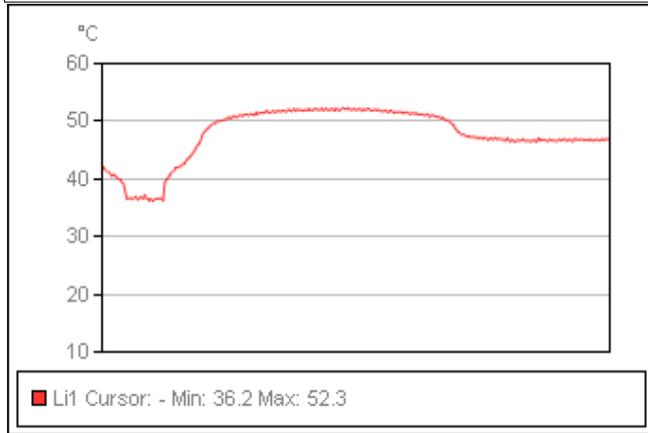
<b>BUILDING / PREMISES</b>	ROOF
<b>EQUIPEMENT</b>	2nd RAW FROM THE LEFT / LOWER LINE
<b>COMPONENT</b>	DETAILED VIEW OF THE DEFECTIVE ELEMENT

The green isotherm surrounds the hottest area .

Replace this panel.  
INTERVENE WITHIN TWO TO FOUR WEEKS.
