# DIAGTECH®

## TECHNICAL DIAGNOSTIC INFRARED THERMOGRAPHY ULTRASOUND

### PREVENTIVE MAINTENANCE INSPECTION : PERTINENT EXAMPLES OF PROBLEMS THAT CAN BE DETECTED WITH INFRARED THERMOGRAPHY

Thermographic inspection of some equipments

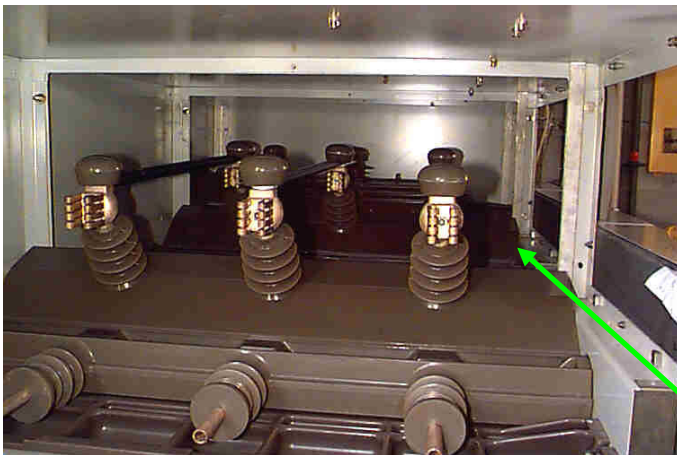
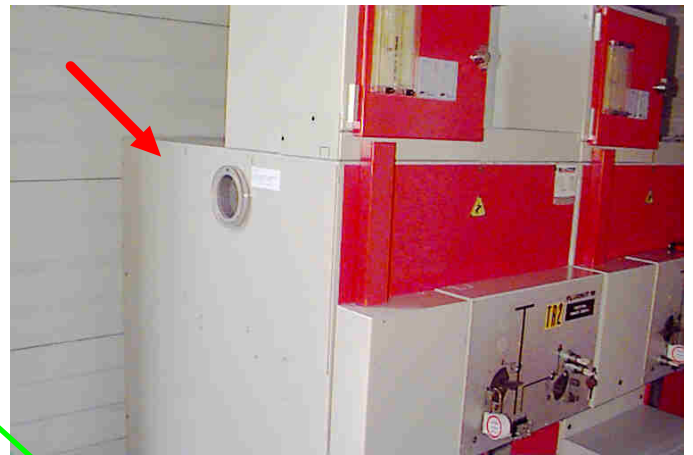
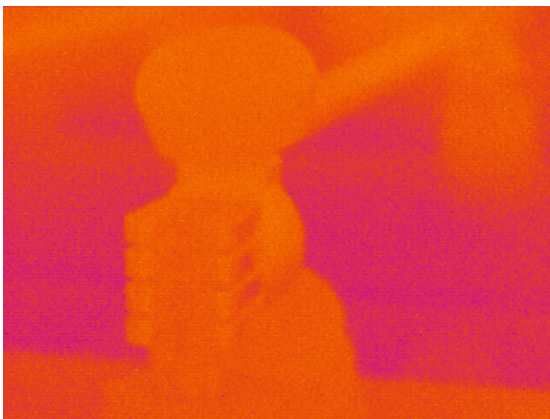
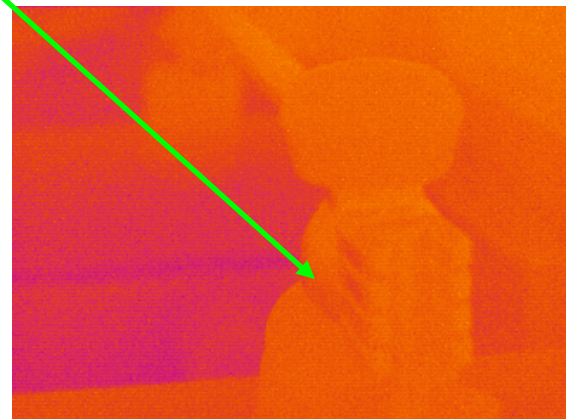
Thermograms recorded through the sight glass, the high tension cells being on charge.  
As you can see, there are no defects.  
The periodic thermal supervision of the most sensitive zones through a sight glass is the best guarantee to discover a malfunction at its beginning.

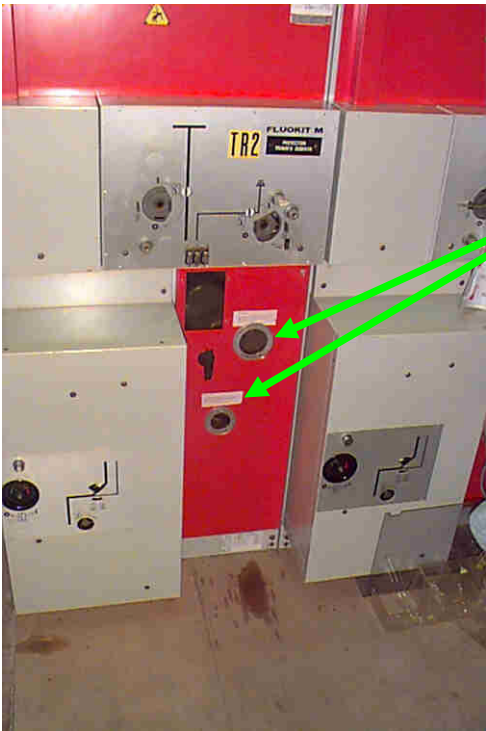
**SETTING OF TWO SIGHT GLASSES ON A CIRCUIT BREAKER CELL.**

**IT'S NOT POSSIBLE TO SCAN THE SET OF CONNECTIONS WITH ONLY ONE SIGHT GLASS. THE PHOTO OF THE INSIDE OF THE CELL SHOWS THAT THE DOUBLE INSTALLATION IS ESSENTIAL. SIGHT GLASS DIAMETERS ARE ADAPTED TO THE NEED OF MEASURING.**

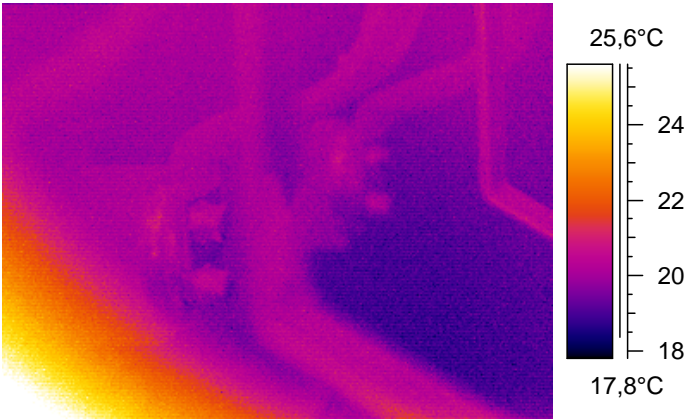
Connections on the left lower part of the circuit breaker.

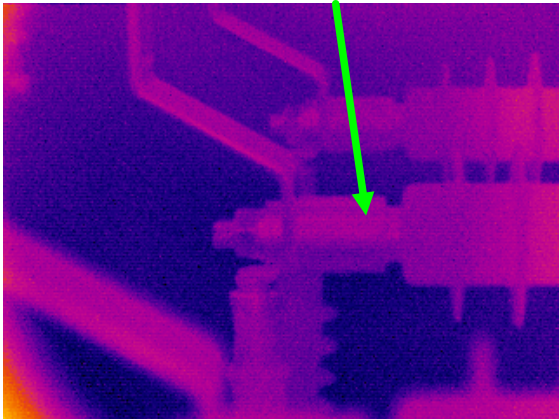
Cable connections on the lower part of the cell.
