EXAMPLE OF DAMAGE TO A SOLAR PANEL

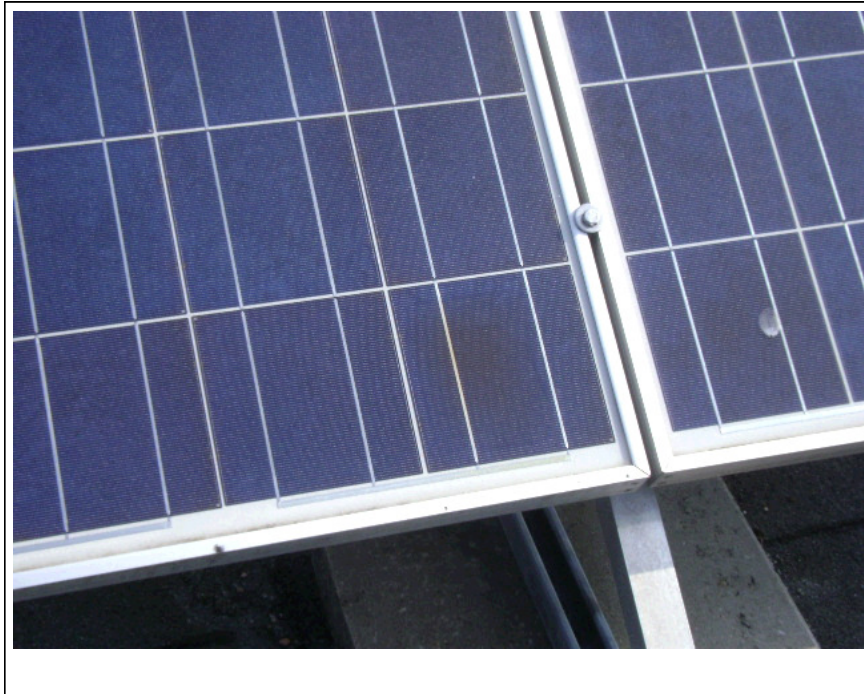
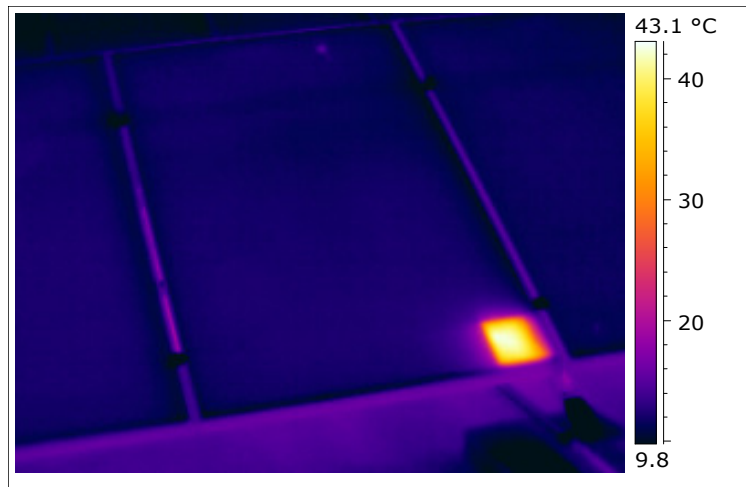
On this panel the defect is more pronounced. We can see, in this photo, darkening of the area in question. Replacement of the panel is necessary to reduce risk of fire and damage to other panels.
